# Manhole Inspection Summary

Manhole # S21KK\_036MH

Insp Date: **5/31/07 10:02 AM**

**Location** Address: **1825 WALBROOK AVE**

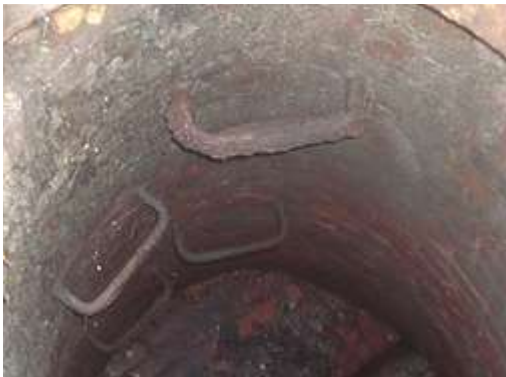
Defect 1

**Steps** Count: **4** Missing: **0** ☒ **Corroded**

CORRODED STEPS

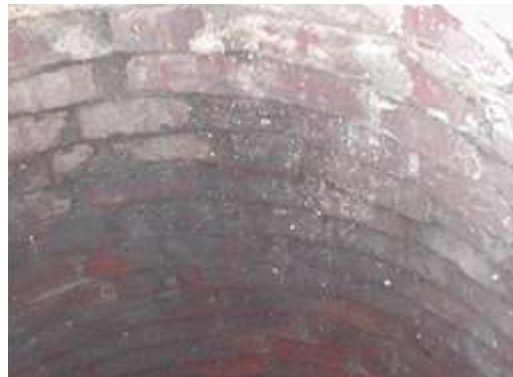
Defect 3

Infiltration: ☐ None ☐ Joint ☐ Cracks ☐ Mortar ☐ Roots ☒ **Wall**

INFILTRATION OF CORBEL WALL

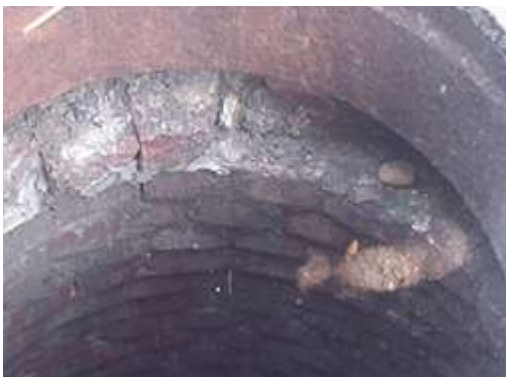
Defect 2

Condition: ☐ Sound ☐ Cracked ☐ Root Intrusion ☐ Loose Brick ☒ **Deteriorated**

DETERIORASTION OF CORBEL

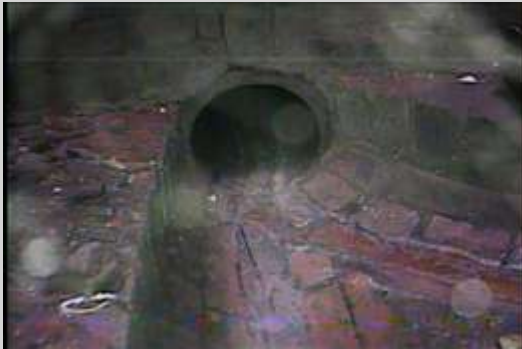
12 O'Clock Outflow

8 in. Circular Gravity Sewer  
Pipe Out @ 12 O'Clock

Pipe Height: **8.4** (in.) Rod and Bar (Angled)  
Pipe Material: **Clay** ☐ Pipe Lined  
Invert Depth: **9.31** (ft.) Flow Characteristics: **Slow**  
Deposits: ☒ None ☐ Mud ☐ Sludge ☐ Debris ☐ Grease  
Silt Depth: (in.) Deposits Extent:  
Infiltration: **None** Pipe Seal Cond: **Sound**

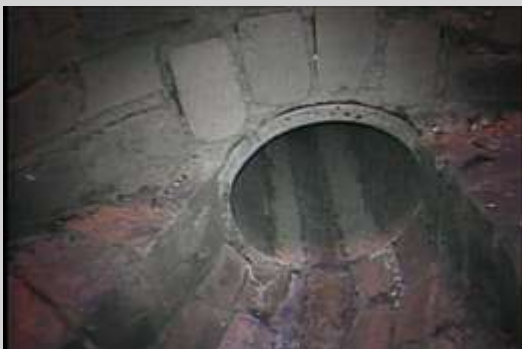
3 O'Clock Inflow

8 in. Circular Gravity Sewer  
Pipe In @ 3 O'Clock

Pipe Height: **8.4** (in.) Rod and Bar (Angled)  
Pipe Material: **Clay** ☐ Pipe Lined  
Invert Depth: **8.89** (ft.) Flow Characteristics: **Slow**  
Deposits: ☒ None ☐ Mud ☐ Sludge ☐ Debris ☐ Grease  
Silt Depth: (in.) Deposits Extent:  
Infiltration: **None** Pipe Seal Cond: **Sound**

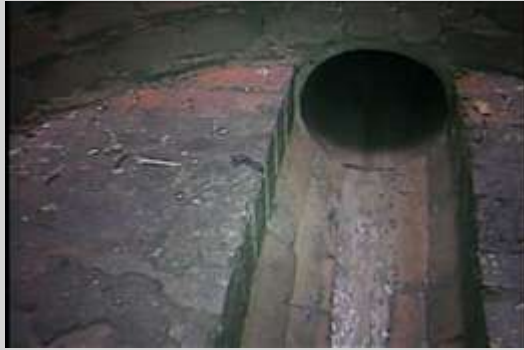
6 O'Clock Inflow

8 in. Circular Gravity Sewer  
Pipe In @ 6 O'Clock

Pipe Height: **7.2** (in.) Rod and Bar (Angled)

Infiltration: **None** Pipe Seal Cond: **Sound**
